**[Docket No. FAA–2022–0891; Project Identifier AD–2022–00585–A,E,R;
Amendment 39–22432; AD 2023–09–09]**

Airworthiness Directives; Various Airplanes, Helicopters, and Engines

The FAA is adopting a new airworthiness directive (AD) for turbocharged, reciprocating engine-powered airplanes and helicopters and turbocharged, reciprocating engines with a certain v-band coupling installed. This AD was prompted by multiple failures of spot-welded, multi-segment v-band couplings at the tailpipe to the turbocharger exhaust housing flange (also referred to as “spot-welded, multi-segment exhaust tailpipe v-band coupling”). This AD establishes a life limit for the spot-welded, multi-segment exhaust tailpipe v-band coupling and requires repetitively inspecting the spot-welded, multi-segment exhaust tailpipe v-band coupling. The FAA is issuing this AD to address the unsafe condition on these products.

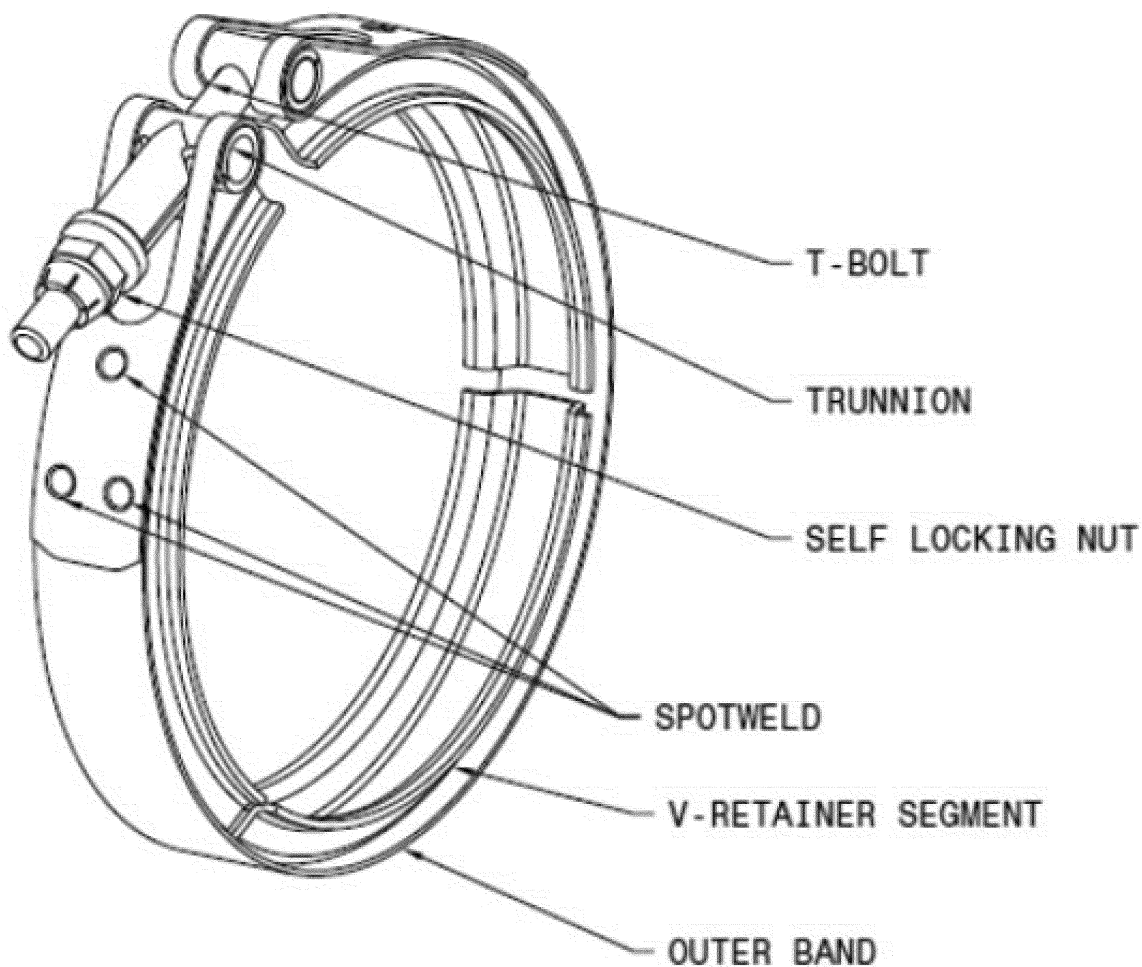
Figure A

The final report concluded that the common denominator in the incidents and accidents reviewed is the spot-welded, multi-segment exhaust tailpipe v-band coupling (see Figure A). These couplings come in either two or three segment varieties. The segments are the number of v-retainer segments, which are attached to the outer band via spot welds. Although multi-segment exhaust tailpipe couplings can also be riveted, the riveted couplings do not create an unsafe condition.

Spot-welded, multi-segment exhaust tailpipe v-band coupling

The majority of the events studied by the working group indicated fatigue failure of spot-welded, multi-segment exhaust tailpipe v-band couplings as a result of stress corrosion cracking that originated at or near a spot weld. This is the same unsafe condition identified in the other v-band coupling AD actions previously referenced. The data studied by the working group contained evidence of pre-existing cracking of the couplings, known embrittlement at the spot weld locations simply due to that manufacturing method, and outer band cupping on the multi-segment couplings (which is the result of age, over-use, and potential over-torqueing). The working group also found that many of the couplings had safety wire across the bolt end. The safety wire could be helpful if there was a bolt or nut failure (extremely rare events) or the nut was missing. However, the safety wire was of no value when the failure was transverse band cracking and total separation at the spot weld. The data studied by the working group indicated many accidents were due to v-band couplings that were of the multi-segment, spot-welded design, when used in a specific location (the tailpipe to the turbocharger exhaust housing flange on turbocharged reciprocating engine-powered aircraft).

This condition, if not addressed, could lead to failure of the spot-welded, multi-segment exhaust tailpipe v-band coupling, leading to detachment of the exhaust tailpipe from the turbocharger and allowing high-temperature exhaust gases to enter the engine compartment. This could result in smoke in the cockpit, in-flight fire, and loss of control of the aircraft. The FAA is issuing this AD to address the unsafe condition on these products.
