SEL-32-08

LANDING GEAR - MAIN LANDING GEAR BUSHING INSPECTION

172S

172S12666 thru 172S13014

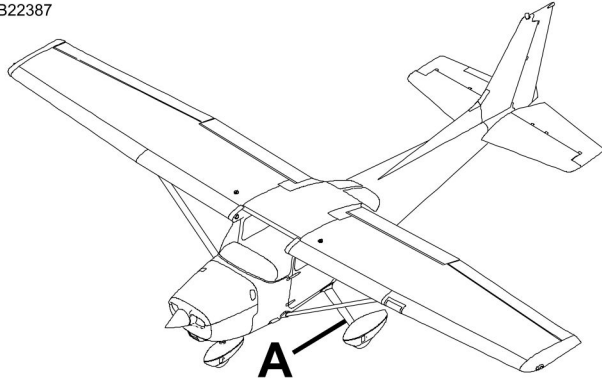
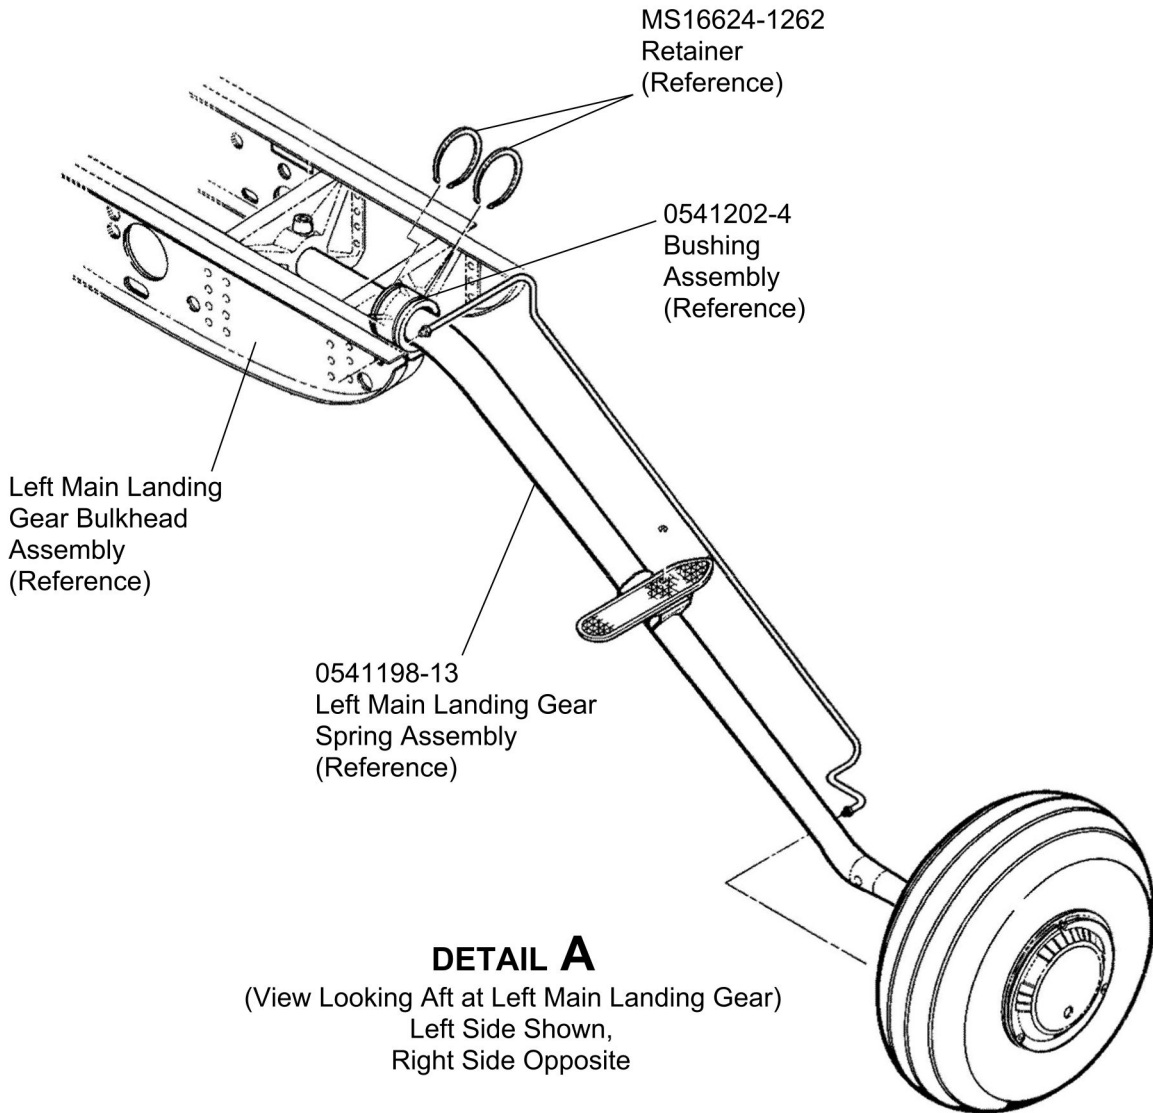
Figure 1. Main Landing Gear Bushing Inspection (Sheet 1)

5. (Refer to Figure 1, Sheets 1 thru 3.) Do a general visual inspection of the 0541202-4 Bushing Assemblies installed in the left and right main landing gear outer support fittings.

NOTE: During the general visual inspection of the 0541202-4 Bushing Assemblies if any of the polyurethane liner is squeezing out of the bushing housing then the 0541202-4 Bushing Assembly must be replaced.

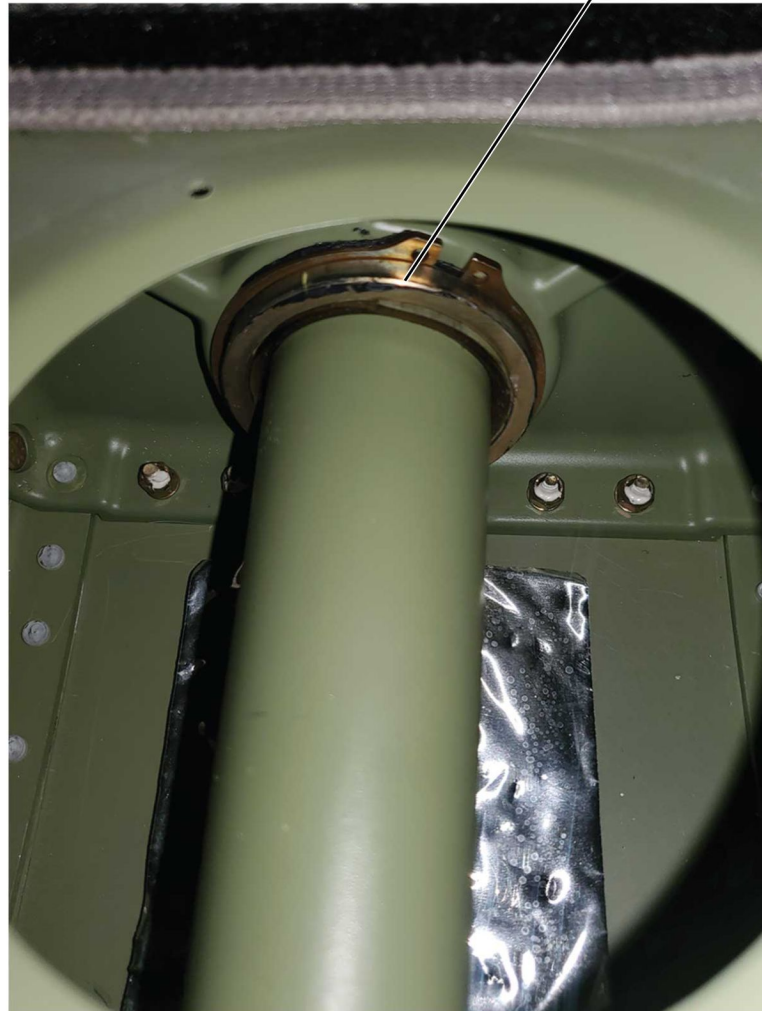
Figure 1. Main Landing Gear Bushing Inspection (Sheet 2)

Good Bushing
(View Looking Outboard at Left Gear Bushing)

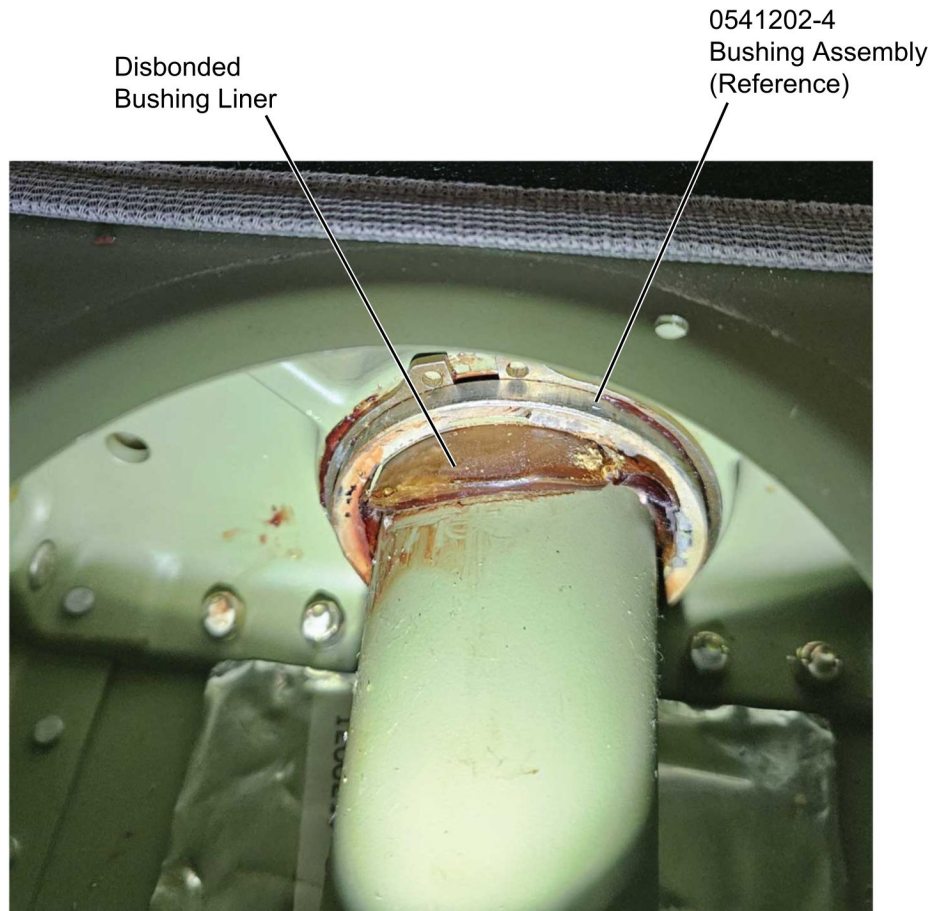
Figure 1. Main Landing Gear Bushing Inspection (Sheet 3)

To do a general visual inspection of the main landing gear bushing at the outboard bulkhead for disbonded liner and replace the bushing if the liner is disbonded. A disbonded liner can cause premature main landing gear and main landing gear outboard bulkhead bushing wear.

Bad Bushing
(View Looking Outboard at Left Landing Gear)

- A. If both 0541202-4 Bushing Assembly liners are not disbonded, go to Step 8.
- B. If a 0541202-4 Bushing Assembly liner is disbonded, do the steps that follow to replace each bushing assembly:
 - (1) Jack the airplane. (Refer to Cessna Model 172 (Series 1996 and On) Maintenance Manual, Chapter 7, Jacking - Maintenance practices.)
 - (2) Remove the main landing gear. (Refer to Cessna Model 172 (Series 1996 and On) Maintenance Manual, Chapter 32, Main Landing Gear - Maintenance Practices, Main Landing Gear Removal/Installation.)
 - (3) Remove and keep the two MS16624-1262 Retainers.
 - (4) Remove and discard the 0541202-4 Bushing Assembly from the outboard support fitting.

- (6) Apply ROYCO 11 MS (or equivalent) Grease to approximately 11 inches on the top end of the tubular strut of the left and right main landing gear and to the outer surface of the new 0541202-4 Bushing Assembly.
NOTE: Using any other grease other than a moly disulfide based grease may cause deterioration to the bushing liner material of the newly installed bushing assembly.
NOTE: For ease of installation cool the 0541202-4 Bushing Assembly to 0 °F before the installation of the tubular strut.

- (7) Install the 0541202-4 Bushing Assembly in the outboard support fitting.
 - (8) Install the kept two MS16624-1262 Retainers with the flat side of each retainer positioned towards the edge of the 0541202-4 Bushing Assembly.
